NC Active Transportation Alliance (NCATA) Background Paper

Subject: Improper Installation of "Rumble Strips" in North Carolina

Attachment 1: Examples of the Improper Installation of Rumble Strips

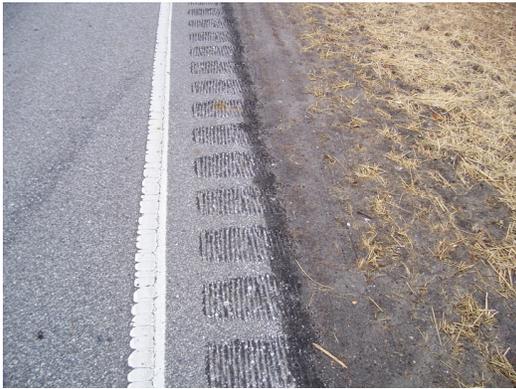
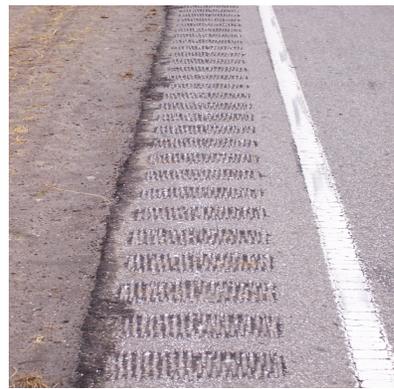
Eastern North Carolina: Highway 17 in Brunswick County

A specific example where it appears that the contractors applying the rumble strips are either unaware of the guidance or are ignoring it can be found on Rte 17 in Brunswick County where the rumble strips start near the intersection with Cherry Tree Rd. and go seven miles south, essentially wiping out all of the narrow paved shoulders. In addition the rumble strips are continuous (without periodic breaks) making it dangerous to enter or leave the bike lane. In these areas, there is no alternate continuous route for north / south travel. The following pictures illustrate these unsafe conditions:

- NCDOT develop and enforce a consistent rumble strip design standards and implementation practice for all 14 Divisions across the state. These standards should be consistent with AASHTO and FHWA guidance.
- The NCDOT Bicycle Division make this an issue of specific concern
- Local MPO and RPO Transportation Advisory Committees address this situation with their NCDOT Divisions
